**UPPER PATUXENT RIVER WATERSHED RESTORATION ACTION STRATEGY (WRAS)  
FORM 1 -- Catchment Information**

Subwatershed: Bear Branch

## UPPER PATUXENT RIVER WATERSHED RESTORATION ACTION STRATEGY (WRAS) FORM 2 -- Site Information

Site Name: Marymont Apartments Address: Mulberry Street  
 Site Owner: Equity Residential Properties  
 State Plane Coordinates of Site Centroid: X: 1350845 Y: 518060 Date: 5/20/03  
 Personnel: PM Weather: sunny, 70F deg  
 Area (ac): 9.8 Impervious Area (ac): 6.6  
 Percent Impervious: 68% Soil Recharge Factor (S): 0.111  
 WQ<sub>v</sub> (required): 0.539 Re<sub>v</sub> (required): 0.06  
 Property Area (ac): 9.8 Property Area Included in Site: 100%  
 Amount of Catchment Occupied by Site: 100%

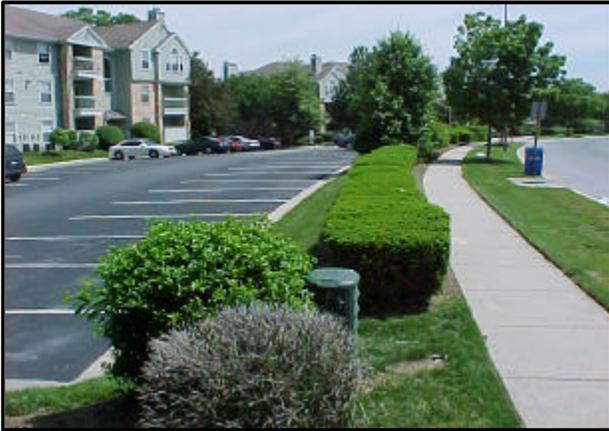
850

No. <u>850</u>	Description: <u>looking east along southern (front) portion of property</u>
No. <u>851</u>	Description: <u>looking north along west portion of property</u>
No. <u>852</u>	Description: <u>looking north along east portion of property</u>
No. <u>853</u>	Description: <u>looking west along south (front) portion of property</u>
No. <u>854</u>	Description: <u>looking south between eastern-most buildings</u>
No. <u>855</u>	Description: <u>looking west along north side of property</u>
No. <u>856</u>	Description: <u>typical building with downspouts</u>
No. <u>857</u>	Description: <u>typical retaining wall</u>
No. <u>858</u>	Description: <u>looking south along west portion of property</u>
No. <u>859</u>	Description: <u>looking east along north side of property</u>
No. <u>860</u>	Description: <u>brick retaining wall on north side of property</u>

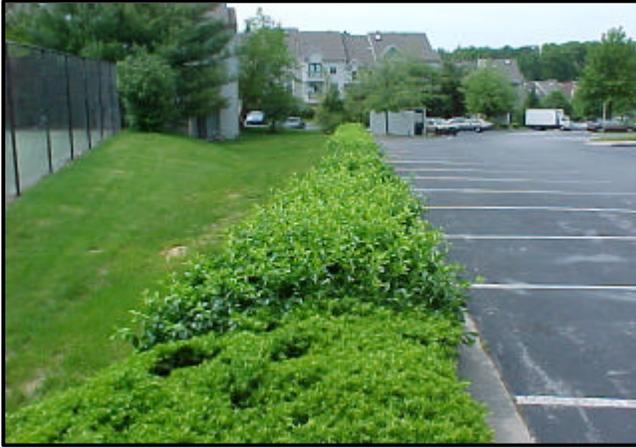
876

No. <u>876</u>	Description: <u>looking north</u>
No. <u>870</u>	Description: <u>looking south</u>
No. _____	Description: _____

IMP Size = 2,467 sq ft

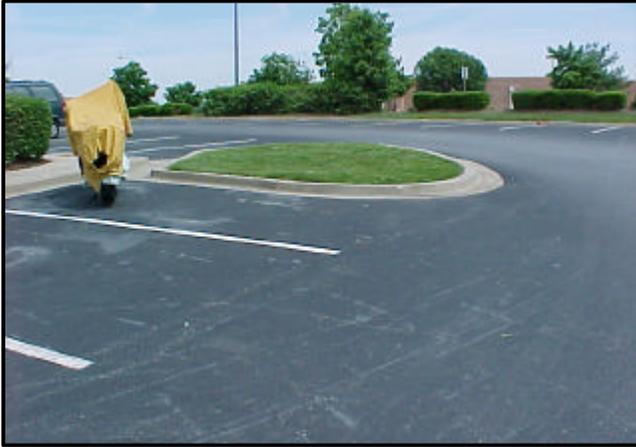
875

No. <u>875</u>	Description: <u>looking south</u>
No. _____	Description: _____

**Comments** IMP treats 38% of the drainage area  
IMP size = 237 sq ft  
 \_\_\_\_\_  
 \_\_\_\_\_  
 \_\_\_\_\_  
 \_\_\_\_\_  
 \_\_\_\_\_  
 \_\_\_\_\_
